# Evje Ridehall

Dilling, Norway

Keller installed about 3300 pcs of Ø800 mm lime-cement columns to stabilize the ground under a new private building for horses.

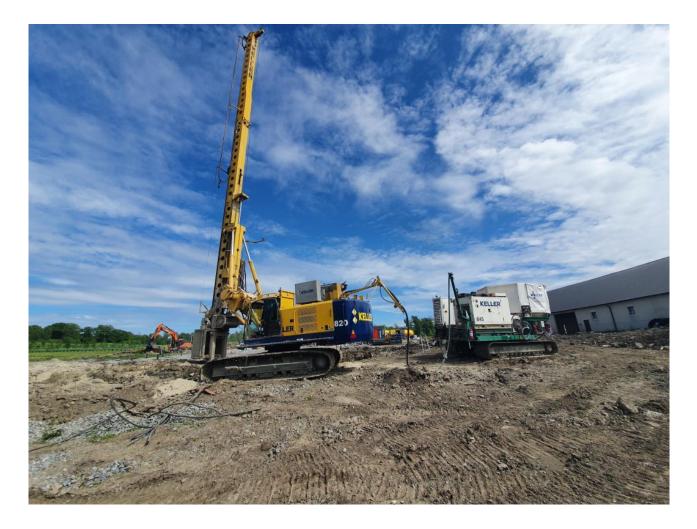
The lime-cement columns were installed in a predefined grid pattern to stabilize the soil.

The solution in the project was to remove the obstacles in the ground with an excavator and change out the soil in the top layer. In some areas there were no need for this as there was only clay all the way from the top. Keller made around 3300 pcs Ø800 lime cement columns with average length of around 7 meters. The columns were tested with the FKPS method where a wing is being pushed down in the column with a separate drilling rig. The strength of the columns is then measured. The strength was well above 300 kPa within 14 days after production.
